PROJECT REPRESENTATIVE'S DAILY REPORT

Pg. 1
Report No. 072
Date: 2014-12-01
Day: Monday

Project: Renovation and Addition to Tewksbury Town Hall

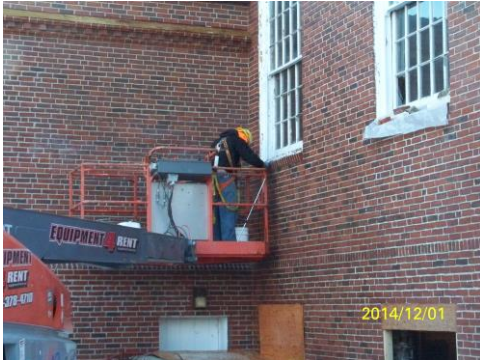
Photo showing mason washing down a window sill on the north elevation of the meeting hall.

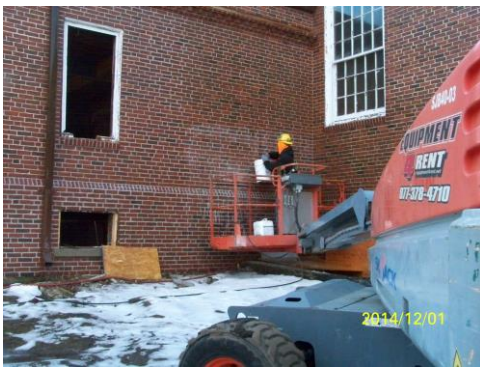
Photo showing mason washing down the west elevation of the north wing.

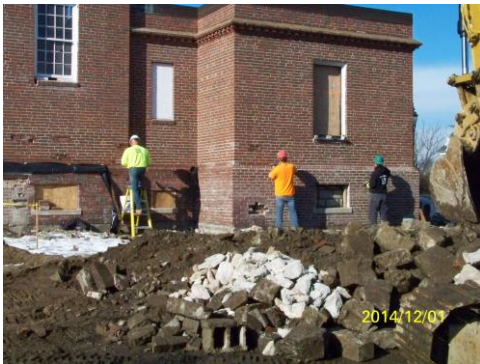
Photo showing masons infilling brick on the east elevation of the north wing.

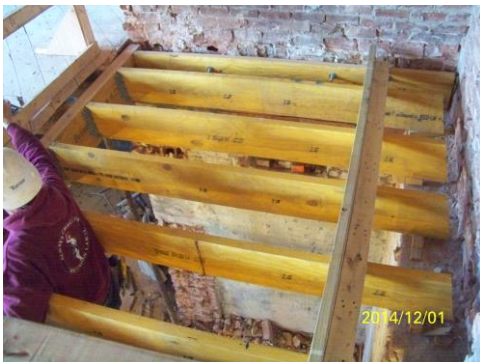
Photo showing carpenter installing flooring infill on the 1st floor, north wing.

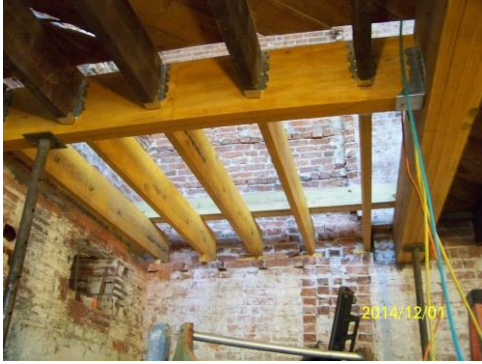
Photo showing the infill as seen from the basement.

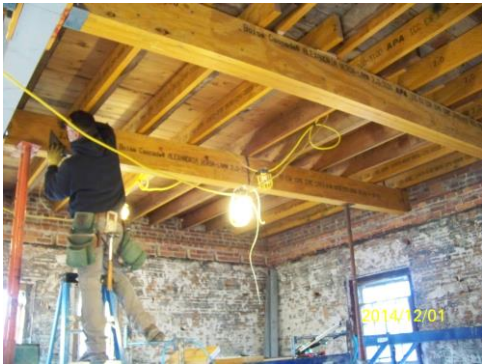
Photo showing carpenter laying out for installation of bridging and blocking.

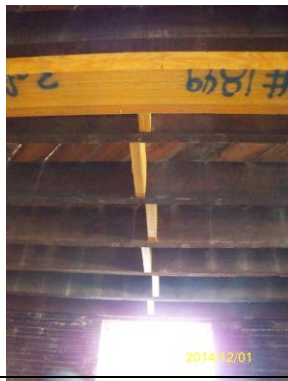
Photo showing some of the bridging and blocking installed for the 1st floor.

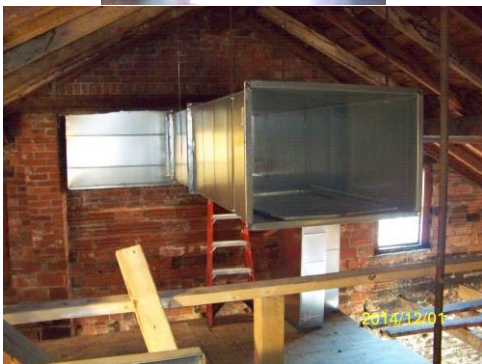
Photo showing some of the duct work installed in the attic.

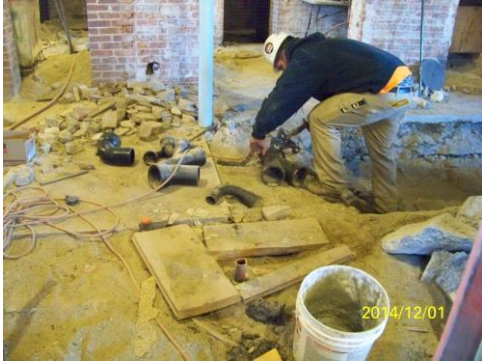
Photo showing plumber prepping pipe for placement.

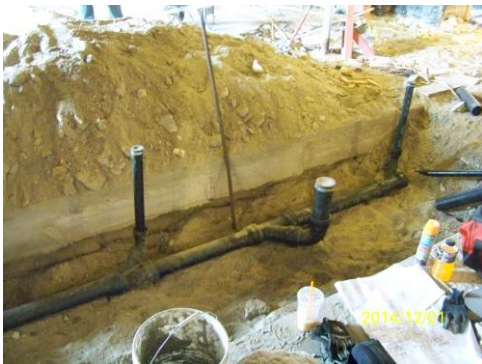
Photo showing some of the piping in place in the trench.

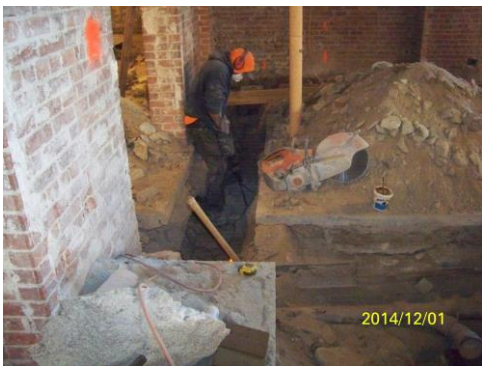
Photo showing workman clearing trench for plumbing.

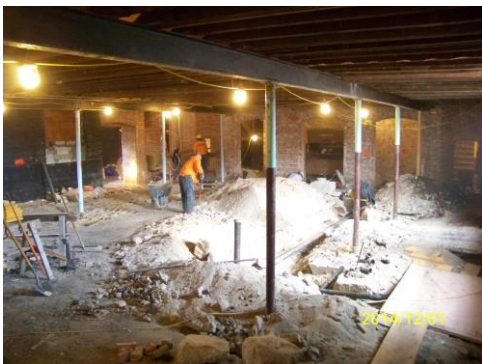
Photo showing workmen clearing debris from the basement.

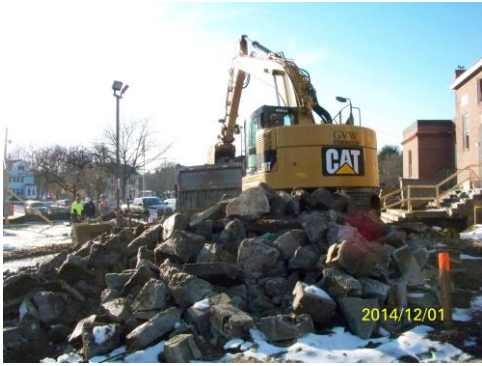
Photo showing some of the site debris being removed.

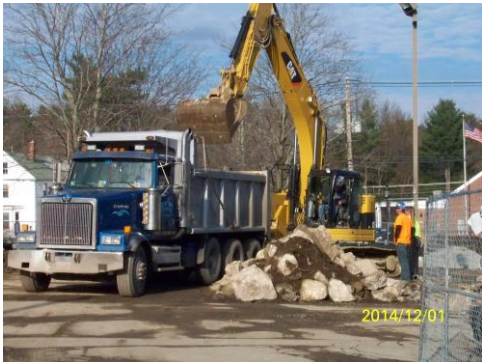
Photo showing site debris being removed.
